2008 Inspection and Annual Site Status Report for the Site A/Plot M, Cook County, Illinois Decontamination and Decommissioning Program Site

Summary

Site A/Plot M was inspected on April 25, 2008. The site, located within a county forest preserve with significant tree and grass cover, is in good condition. No cause for a follow-up inspection was identified.

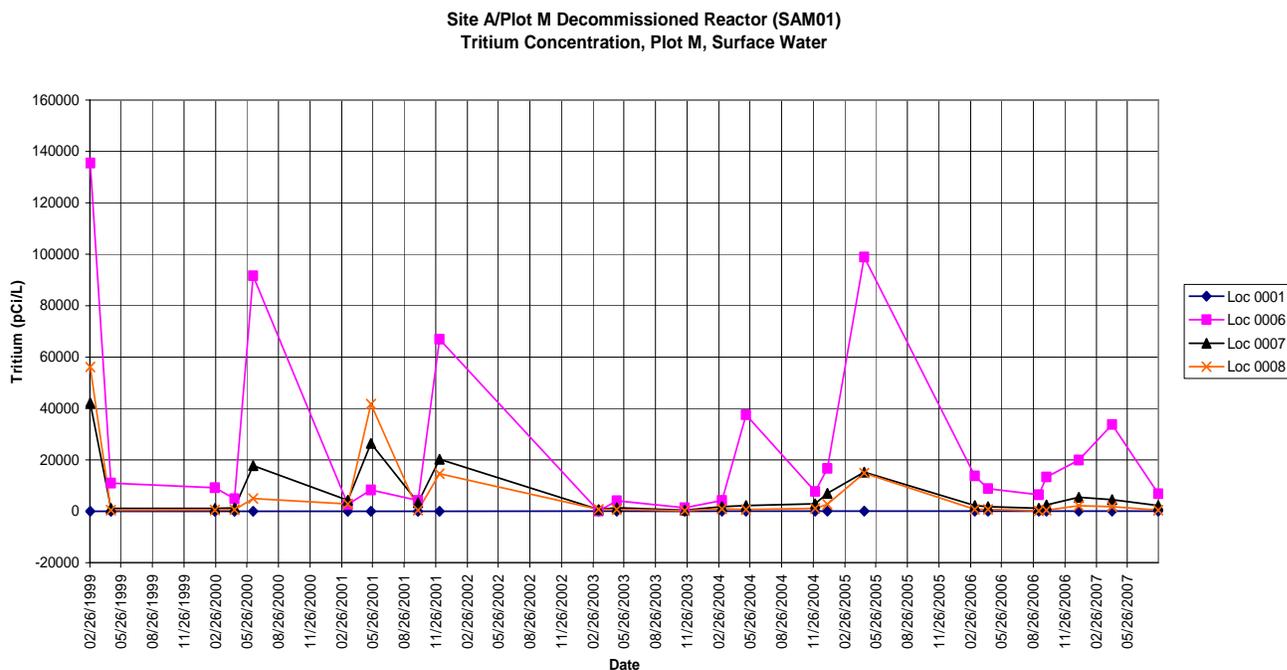
Figure 1. Tritium Activities in Surface Water at Site A/Plot M, Cook County, Illinois

In 2007, tritium levels in the intermittent stream were below the State of Illinois standard of 20 nanocuries per liter (nCi/L), or 20,000 picocuries per liter (pCi/L). Seep activities (Location 0006) ranged from 6.8 nCi/L to 33.8 nCi/L (Figure 1).

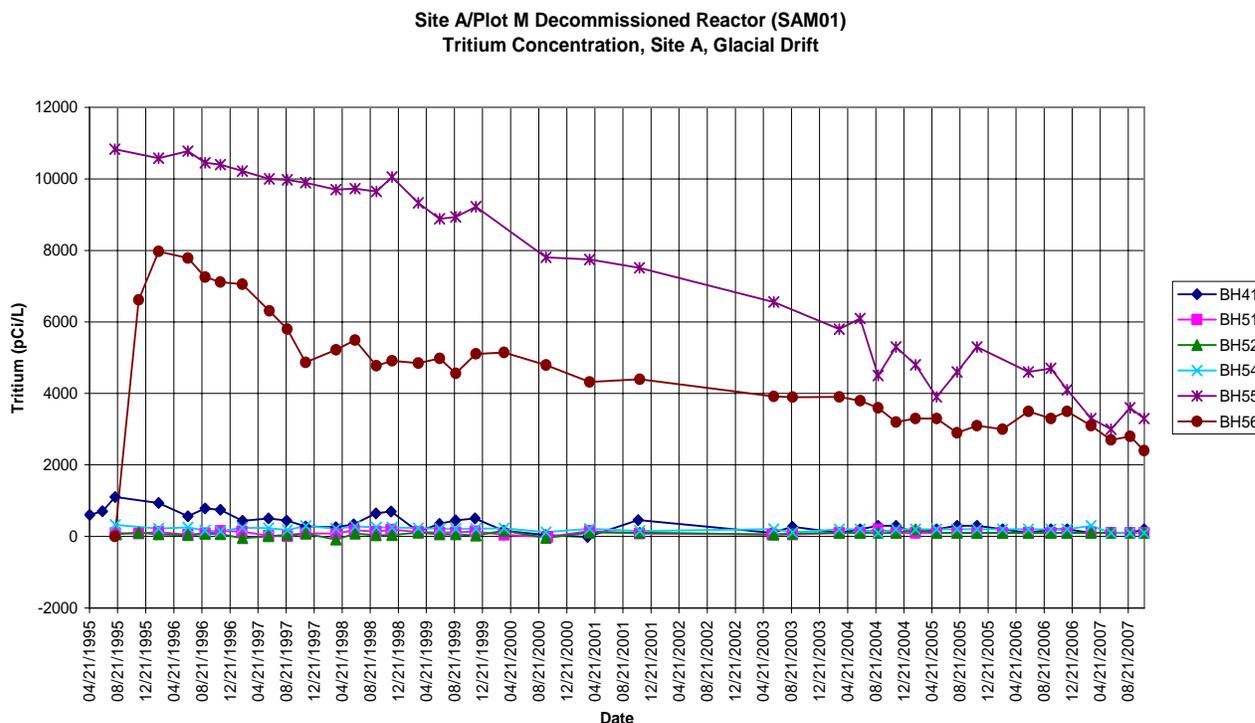
Figure 2. Tritium Activities in Groundwater in the Glacial Drift at Site A, Cook County, Illinois

In 2007, tritium was detected in the groundwater at four of six Site A monitor well locations completed in the glacial drift. None exceeded the standard of 20 nCi/L. Activities continue to decrease and ranged from non-detect (less than 0.1 nCi/L) to 3.6 nCi/L (Figure 2).

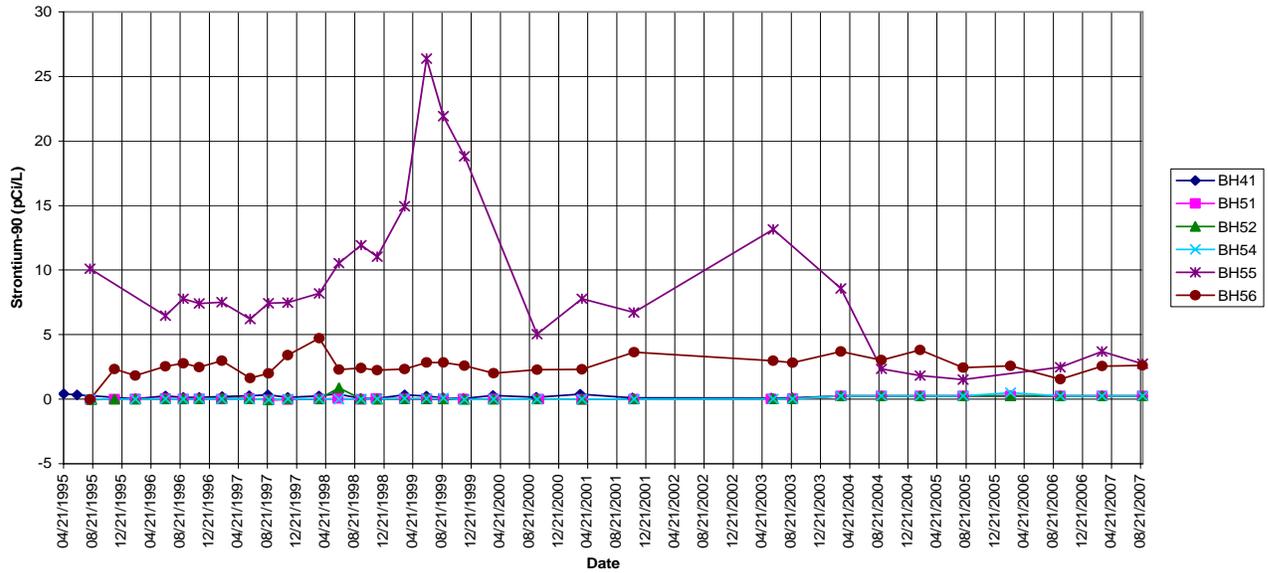
Figure 3. Strontium-90 Activities in Groundwater in the Glacial Drift at Site A, Cook County, Illinois

In 2007, strontium-90 was detected in groundwater at two of six Site A monitor well locations. Activities ranged from non-detect (less than 0.25 pCi/L) to 3.70 pCi/L, but none exceeded the State of Illinois standard of 8 pCi/L (Figure 3).

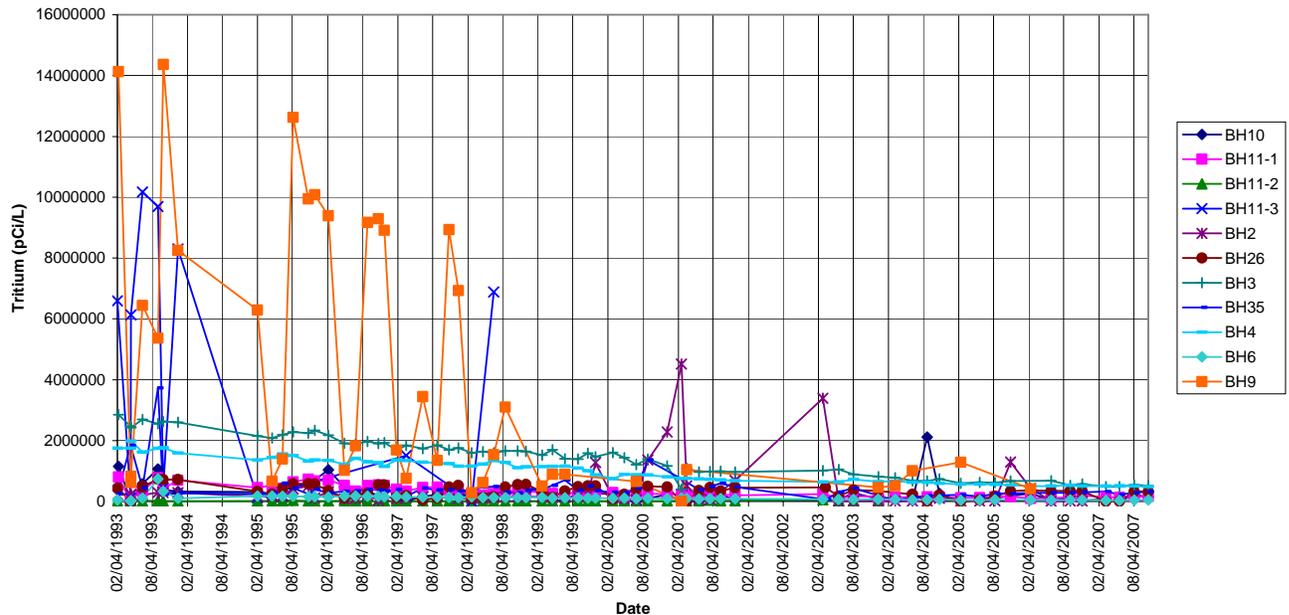
Figure 4. Tritium Activities in Groundwater in the Glacial Drift at Plot M, Cook County, Illinois

In 2007, at Plot M, tritium was detected in groundwater at all nine monitor wells completed in the glacial drift. Tritium concentrations ranged from 1.5 to 1,462 nCi/L (Figure 4). The highest reading was taken at BH9 on March 12, 2007. BH-9 was dry for the remainder of 2007.

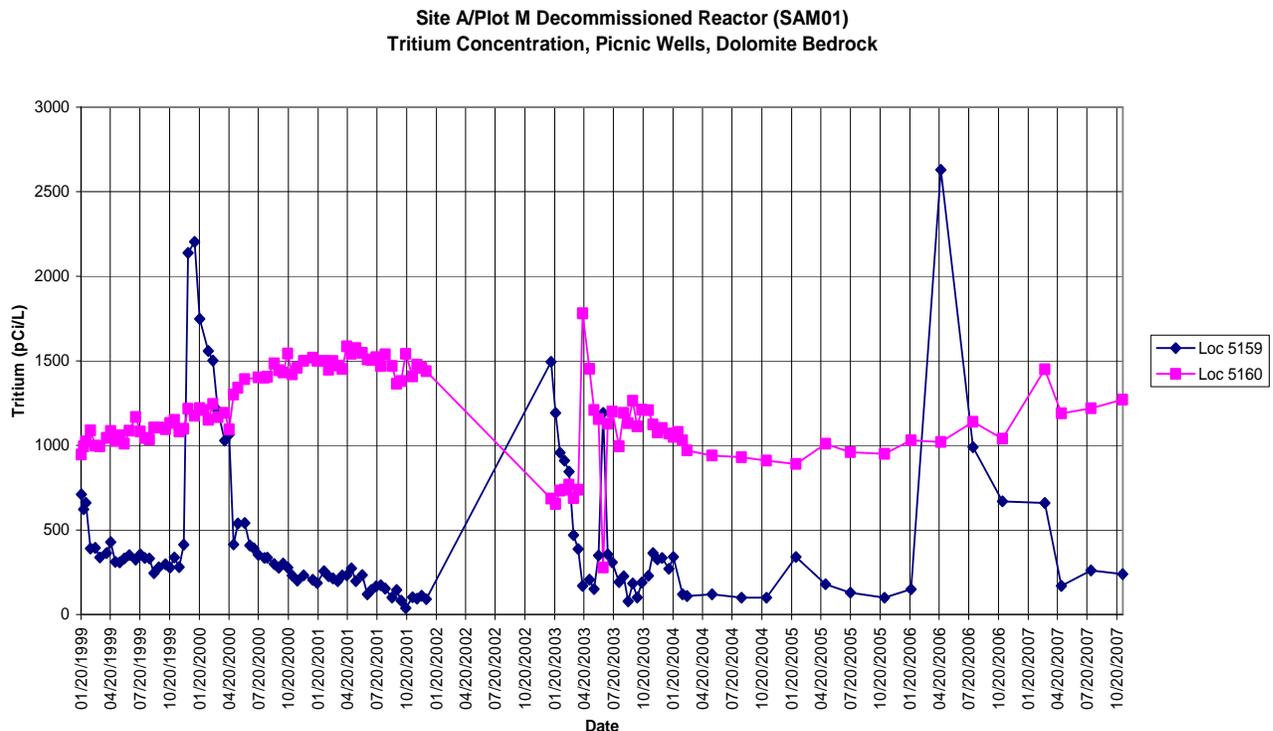
Figure 5. Tritium Activities in Groundwater in the Picnic Wells, Site A/Plot M, Cook County, Illinois

In 2007, tritium was detected in the groundwater at the picnic wells at the Red Gate Woods picnic area. Activities ranged from 0.17 to 1.45 nCi/L (Figure 5). None exceeded the standard of 20 nCi/L.

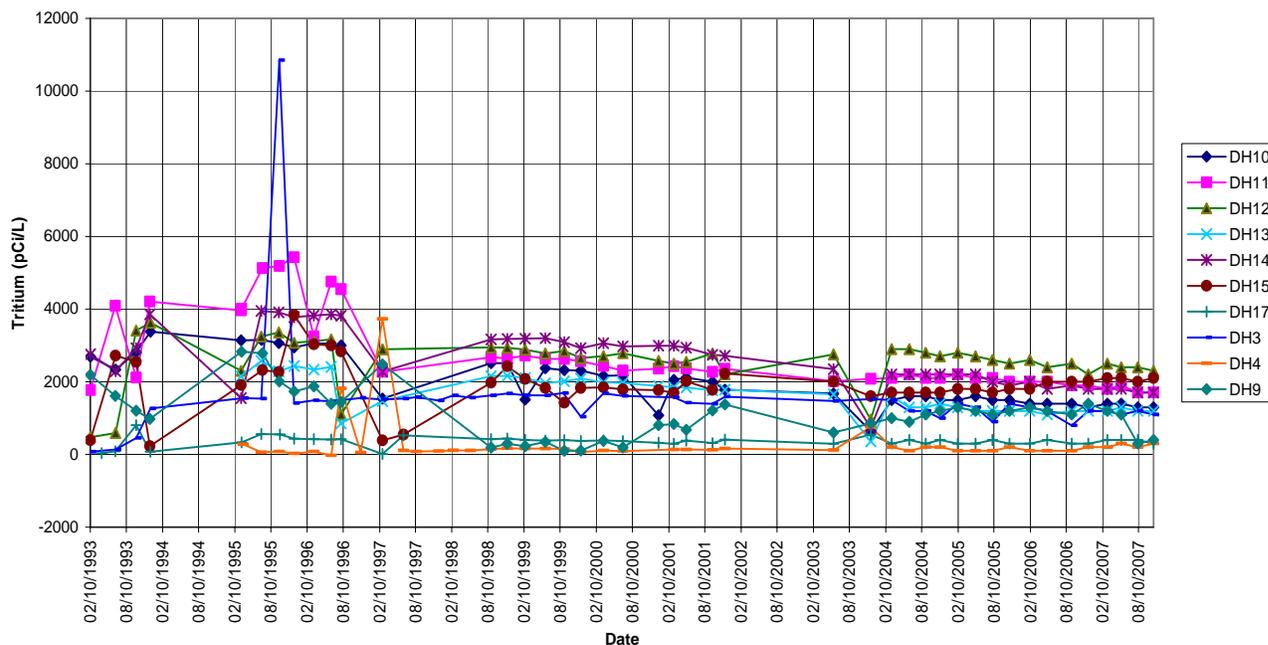
Figure 6. Tritium Activities in Groundwater in the Dolomite Bedrock, Site A/Plot M, Cook County, Illinois

In 2007, tritium activities were detected in groundwater at all ten sampling locations intercepting the dolomite bedrock at Plot M and ranged from 0.2 to 2.5 nCi/L. Activities of tritium continue to decrease (Figure 6). Tritium was not detected in the dolomite bedrock beneath Site A and these monitoring locations were eliminated in 2004 after approximately 30 years of sampling.

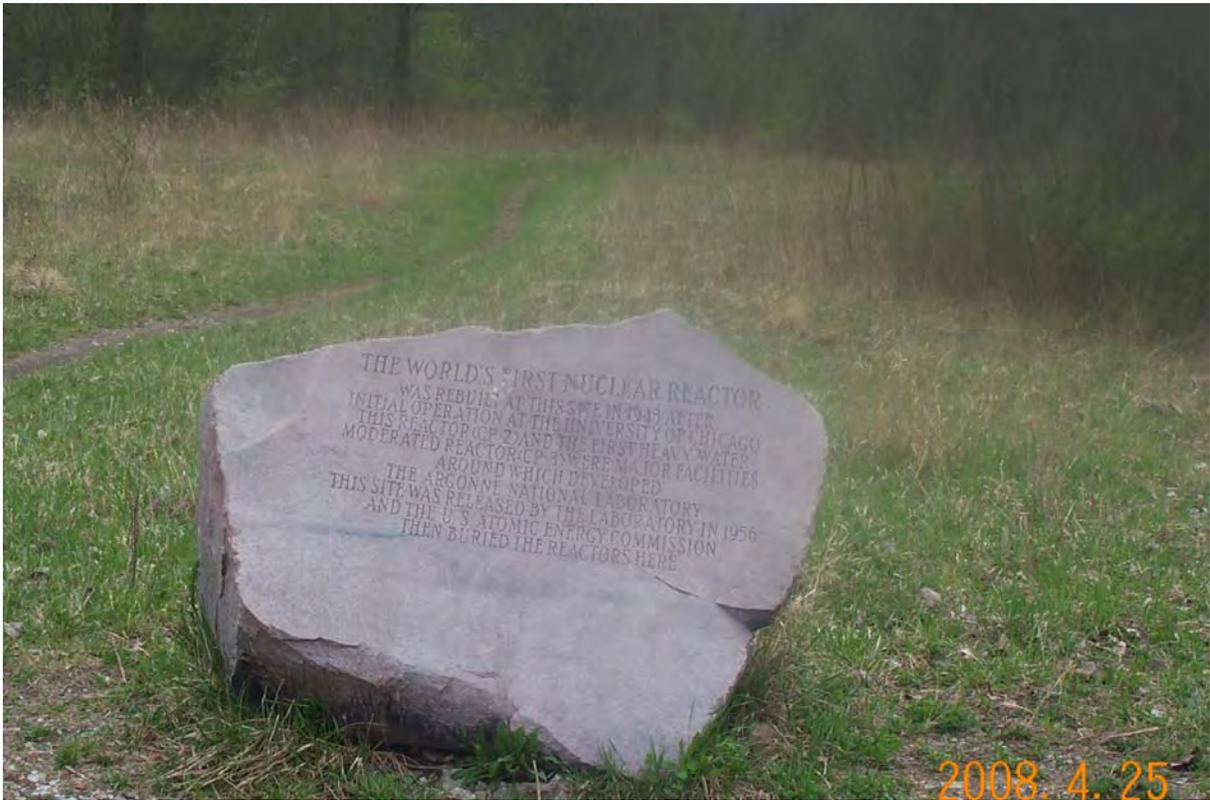
SAM 4/2008. PL-1. Site A Historic Marker.

Inspectors drove to Site A, walked to the center of the area, and examined the historical monument (PL-1) and the monitor wells. The Site A historical monument was in good shape.

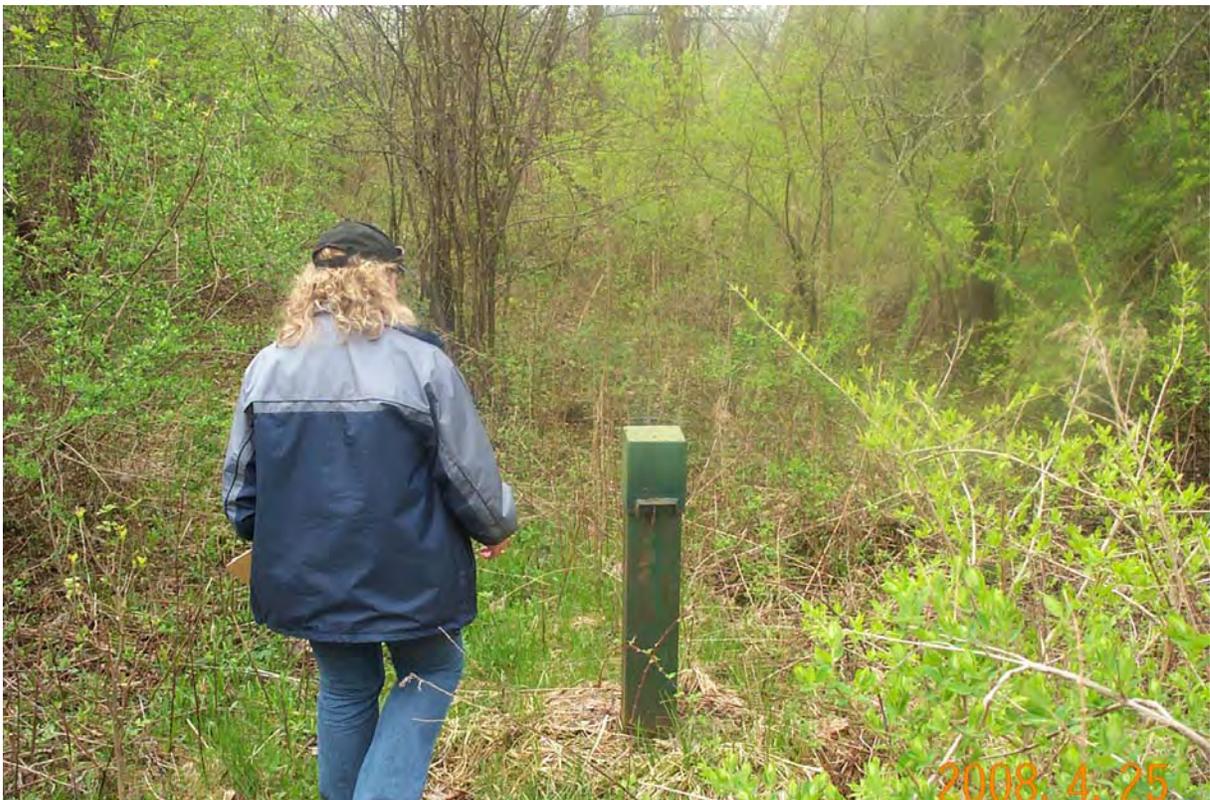
SAM 4/2008. PL-2. Monitor well DH1.

Inspectors walked the perimeter roads of Site A, inspecting monitor wells and observing the general condition of the site. With the exception of monitor well DH1, monitor wells were secured with locks. The lock at monitor well DH1 was missing (PL-2). ANL personnel, aware of the missing lock, were in the process of replacing it. The protective casings of the monitor wells at Site A were not clearly identified with a well number (PL-3). ANL personnel indicated that they would properly label the wells, including the flush mount wells (PL-4). No monitor wells were opened during the inspection. ANL personnel visit the wells quarterly for sampling, ensure well security, and perform required maintenance at that time. The attached drawing depicts most of the active monitor well locations for Site A/Plot M, as established with a global positioning system unit in 1999.

2. No lock was present on monitor well DH1 (page 3).

Recommendation: ANL will provide a new lock for well DH1.

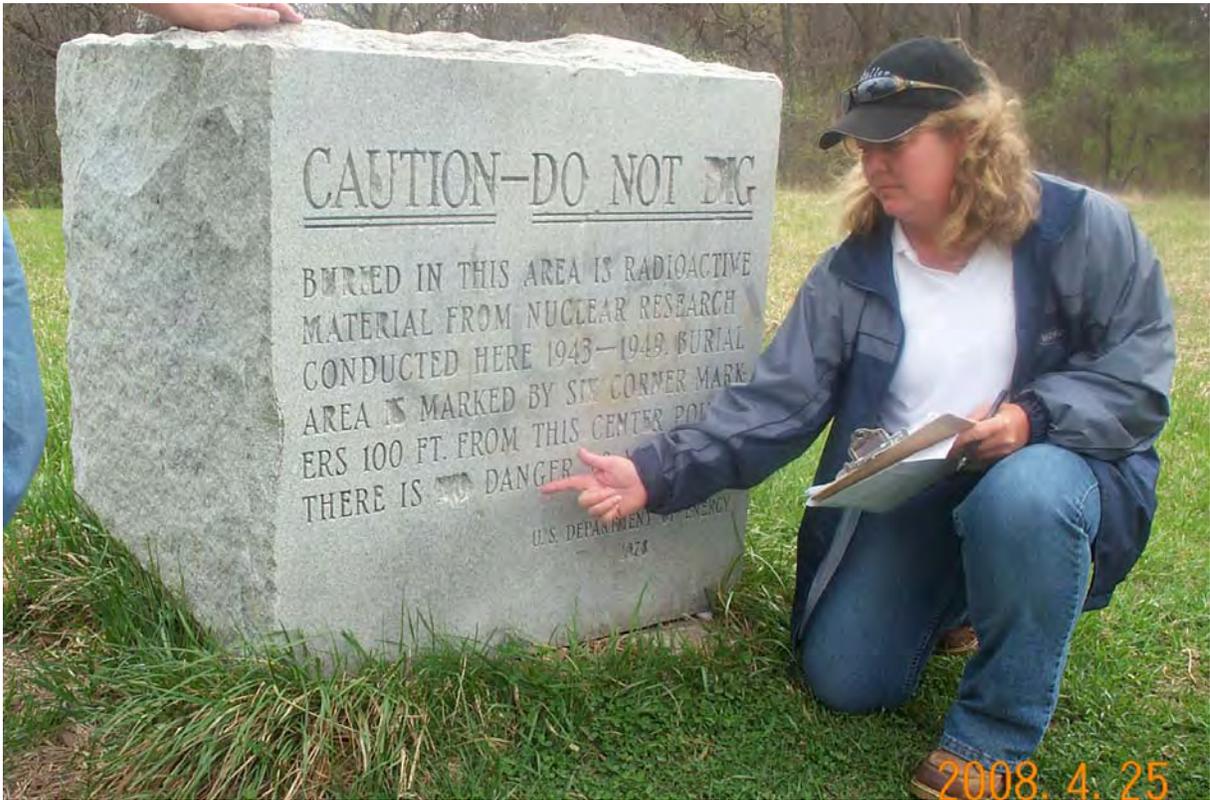
SAM 4/2008. PL-5. Plot M Historic Marker.

The historic monument at Plot M has been vandalized, as noted during previous inspections, but remains functional.

Inspectors drove from Site A to an area leading back to Plot M, and then walked back to Plot M. Minor vandalism was observed on the Plot M historic marker (PL-5). It was noted that the corner markers for Plot M were not identified on the inspection drawing. The corner markers have been added to the detail for Plot M provided in the attached inspection drawing.

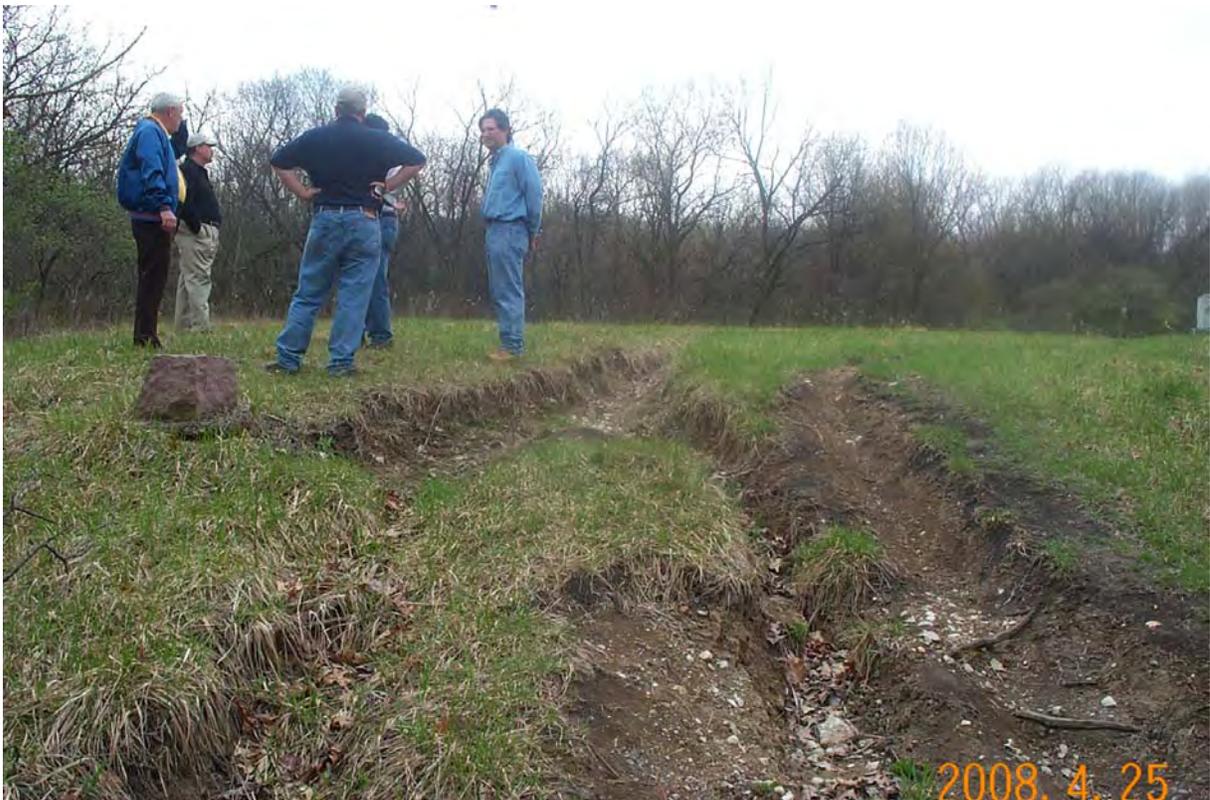
SAM 4/2008. PL-6. Erosion on top of Plot M.

Erosion along footpaths on top of Plot M appears to be worsening. Repairing the erosion is on hold until upcoming work to decommission area monitor wells is complete.

Erosion observed along footpaths that cross over the top of Plot M appears to be worsening (PL-6). Efforts to repair the erosion have been put on hold pending the upcoming abandonment of several monitor wells in the area. ANL personnel believe that the heavy equipment needed to abandon the wells would adversely impact the erosion repairs if they were done first. A request was made that ANL provide DOE-LM with well decommissioning information for Plot M wells that are abandoned.

4. Erosion continues to impact the footpaths crossing Plot M (page 3).

Recommendation: Enough traffic passes over these paths to preclude successfully repairing the erosion by filling the depressions with soil and reseeded. A soil/rock mixture also failed to stabilize the trails. DOE and ANL will consider retaining a landscaping contractor to implement a more effective repair once upcoming well decommissioning activities in the area have been completed.

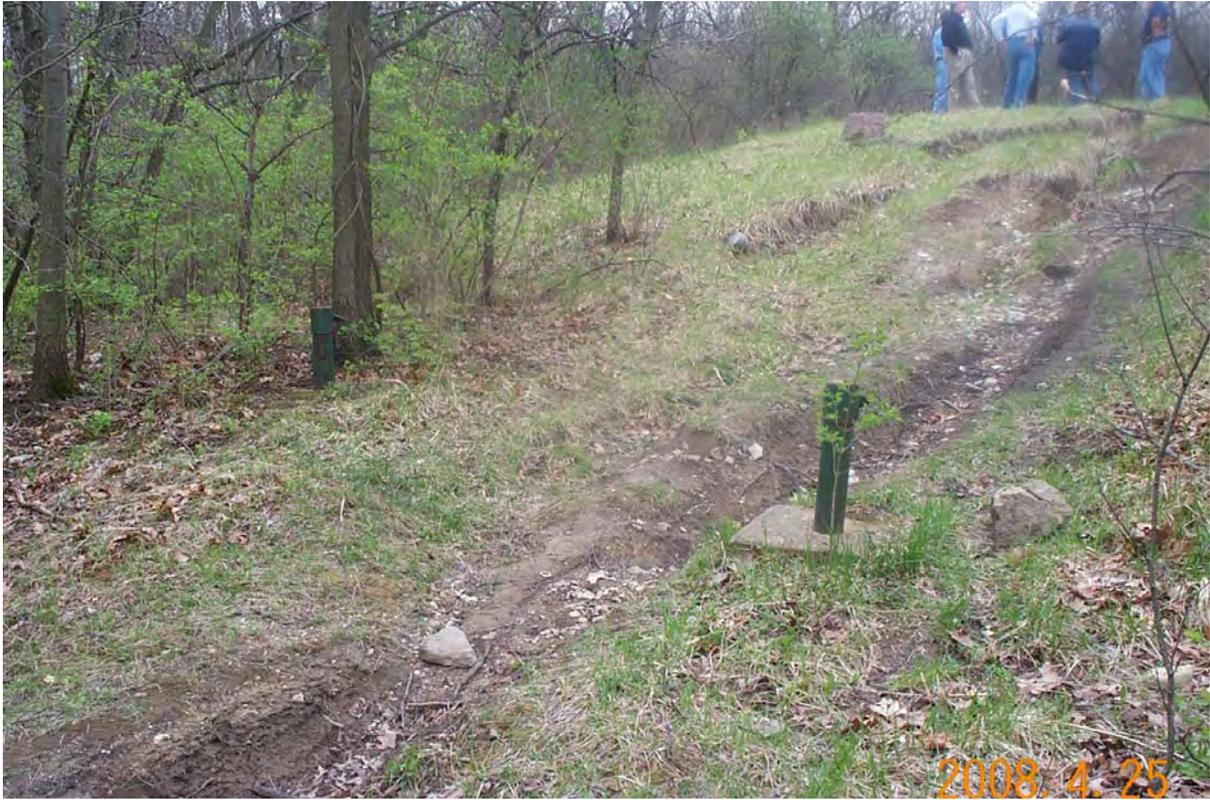
SAM 4/2008. PL-7. Monitor well 11.

The protective casings of the monitor wells at Plot M were not clearly identified with a well number. A request was made that ANL label the protective casings of the Plot M wells. One monitor well at Plot M was heavily damaged (PL-7). ANL personnel identified the damaged well as either BH-11A or BH-11B, but without identification on the well casing it was hard to determine the exact well ID in the field. Although it is hard to see in photo PL-7, a third well is

located between the two green protective casings seen in the picture. The outer metal casing can be seen protruding from the ground surface. The protective casing is completely missing, and the PVC riser inside the outer well casing is not secured. The ability to sample the well has not been compromised by the vandalism. ANL personnel were aware of the damaged well at the time of the inspection and were in the process of having the well repaired. They reported that someone had recently vandalized the well by removing the protective casing. ANL personnel never found the protective casing that had been removed.

6. Monitor well at Plot M found to be damaged. Protective casing was missing, and PVC riser is not secured. The ability to sample this well has not been compromised by the vandalism.

Recommendation: This damaged well needs to be repaired or plugged and abandoned. ANL is currently in the process of addressing this well.
